# Ground Contamination Phase 1 Assessment Plot 1

**Cardiff Peninsula**

**Orion Land & Leisure Ltd**

CPM-HIL-1A-0000-RP-E-  
PL-1001

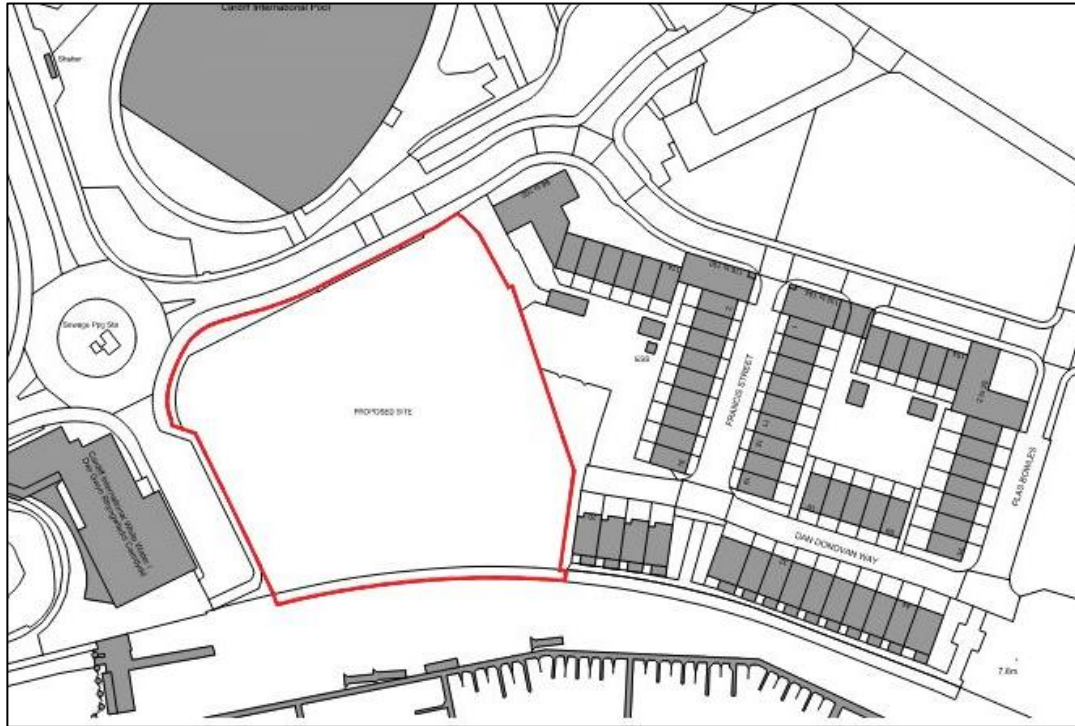
*Figure 1.1 Application Site Boundary*

The Proposed Development is a C3 (Residential) development comprising senior living accommodation (circa 77 no. apartments) with associated car parking, cycle parking and landscaping, as illustrated in **Figure 1.2** overleaf.

The proposed scheme involves construction of a 4 to 5-storey residential block. The ground floor features a mixed-use layout, with residential units situated along the River Ely waterfront to the south, while amenity and plant rooms are positioned to the north. No basement is proposed for the development. The upper levels are designated for residential use exclusively.

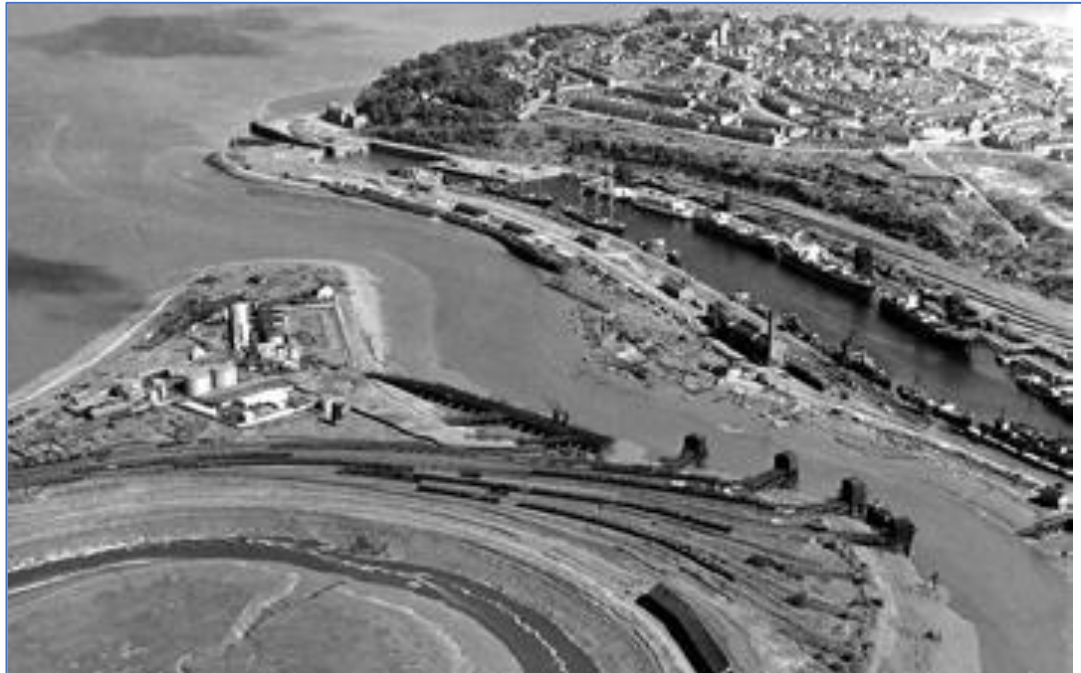
Figure 4.1 Historical Aerial Photograph 1940 (Source: DAS in production)

Figure 4.1 below is an aerial photograph from circa 1940 and Figure 4.2 shows the Site in 2000.

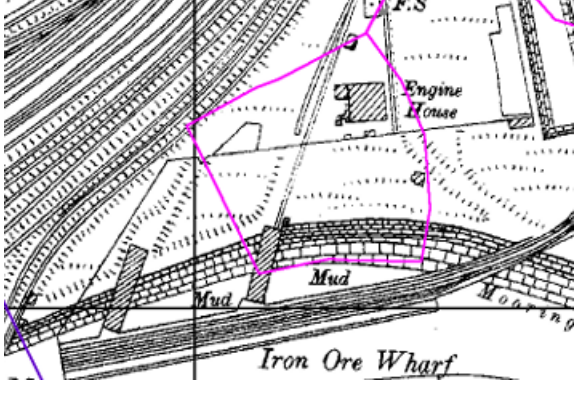
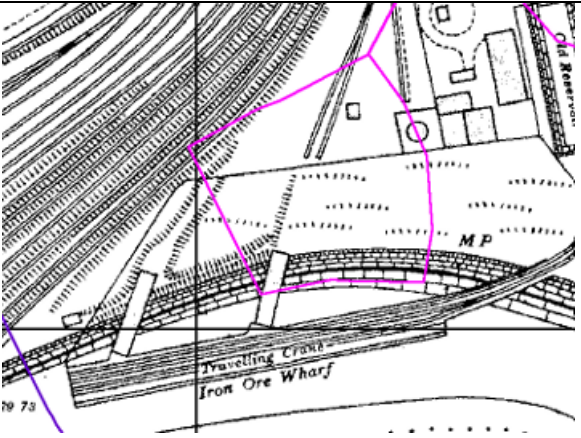
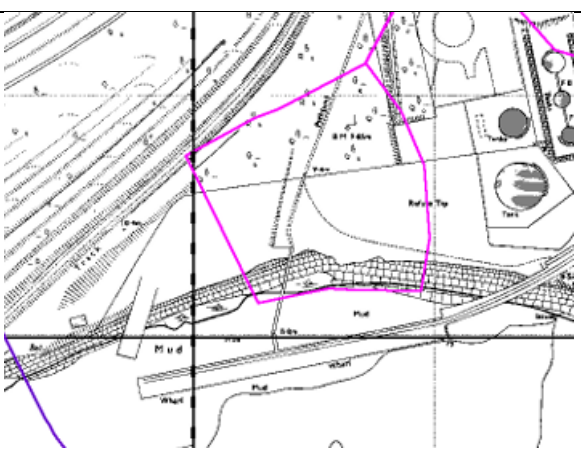
**Figure 4.3** Extracts from Historical Maps to Illustrate the Changes in Land Use  
(Source: A2SI Phase I Desk Study, Cardiff Bay Peninsula, May 2024, Ref: 48224-A2SI-XX-XX-RP-Y-0001-00)

<p>Extract from 1900 1:2500 Scale Ordnance Survey Map</p>

<p>Extract from 1942 1:2500 Scale Ordnance Survey Map</p>

<p>Extract from 1970 1:2500 Scale Ordnance Survey Map</p>

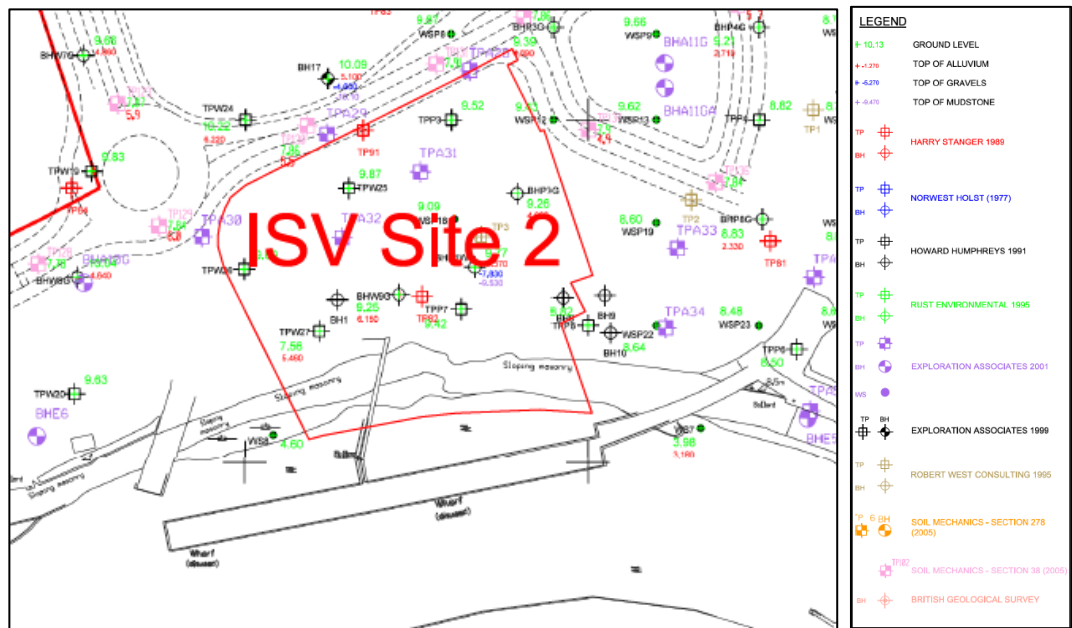
Figure 5.3 Site Investigations Conducted Prior to Remediation (Source: Extract from Figure 5, Arup 2012 Report – ISV Waterfront Site – Review of Existing Geo-Environmental Information)

Plot 1 was previously identified as ‘ISV Site 2 Area’ with Made Ground identified typically as soft/firm, grey-brown, slightly sandy slightly gravelly very silty clay, gravel consisting of fine to coarse mudstone and sandstone, with occasional ash, coal, slag and brick ranging in thickness between 3.0 and 5.0m.

Historical investigations within the ‘Site 2 Area’ which was used as a landfill identified near surface hydrocarbon contamination including PAHs. No significant contamination was identified outside of the landfilled area within the Site 2 boundary. Elevated levels of ground gas (carbon dioxide greater than 1.5% v/v) were also recorded.

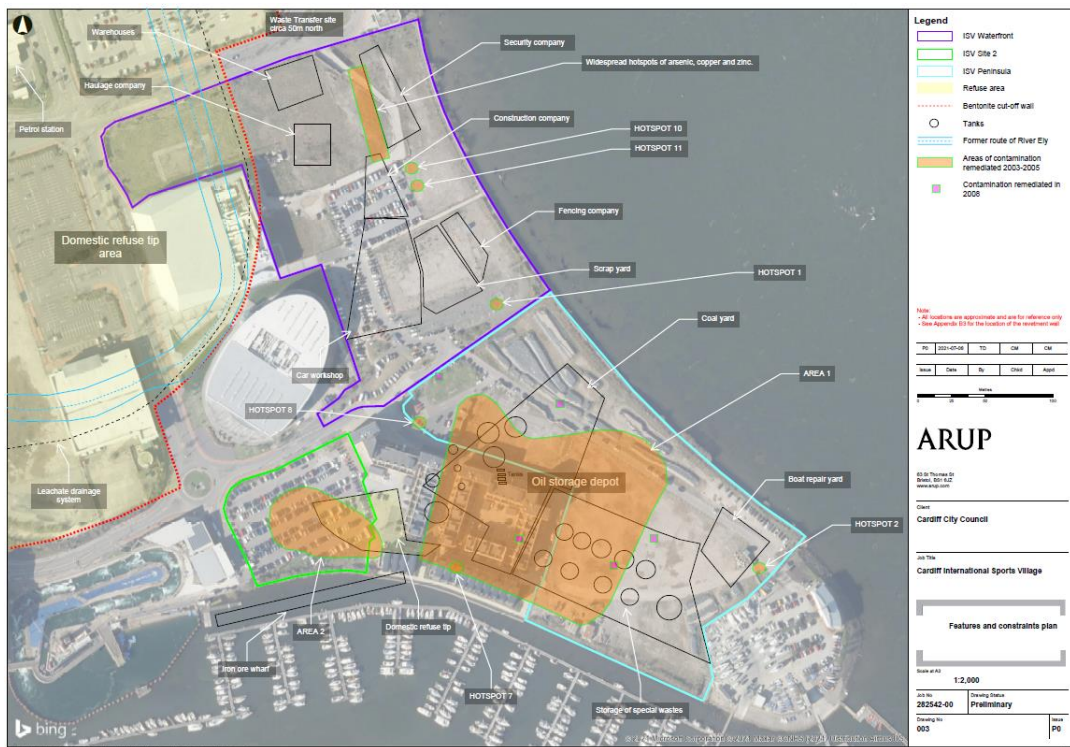
**Figure 5.4** Areas Subject to Remediation in 2003-05 (Source: Drawing 003 from Arup Technical Due Diligence Note, Dated 2021 (Ref: 282542-00))

Available information indicates that the former landfilled area located on the eastern area of ‘ISV Site 2’ was found to be contaminated with hydrocarbons. As part of the remediation works undertaken by Churngold Remediation this area was known as ‘Area 2’ and was subject to excavation, sorting and removal off site of refuse to 3.0m below

No additional remediation was carried out on Plot 1 as part of the 2008 remediation work.
